## Restoring an Imp in Germany – Part One

Stephan Haeuser, Freising, Germany

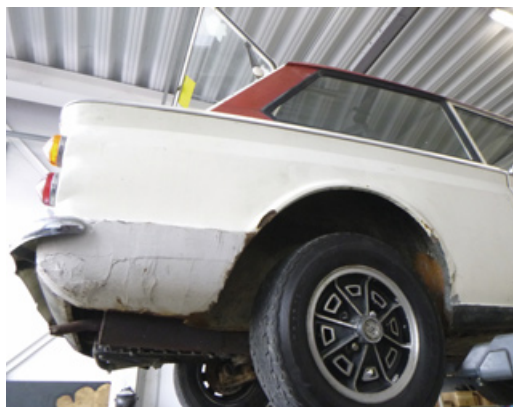
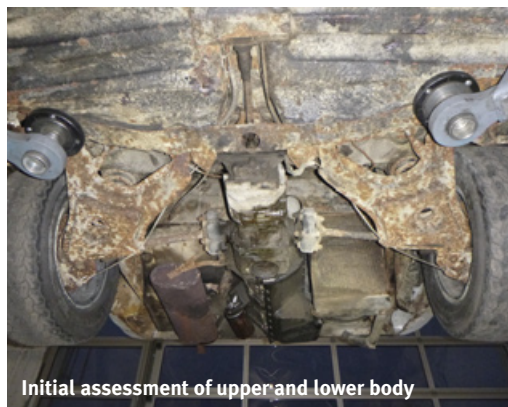
Initial assessment of upper and lower body

a new German owner but in need of repair. I subsequently bought the vehicle in 2019 as an absolute wreck. Colour was white with a red roof and interior. The restoration started in October 2020.

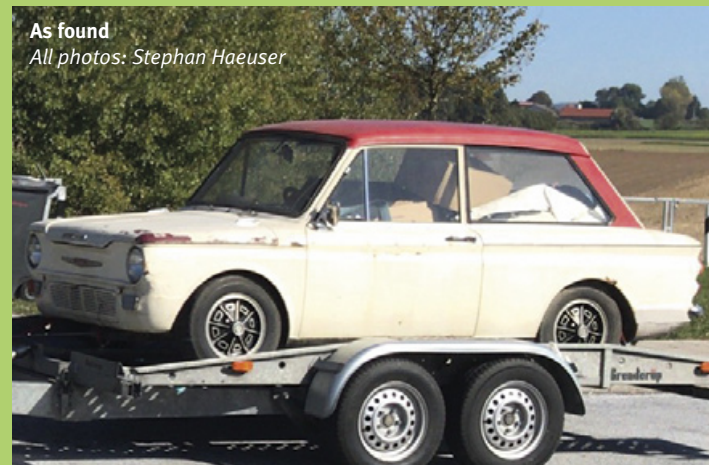
As found  
All photos: Stephan Haeuser

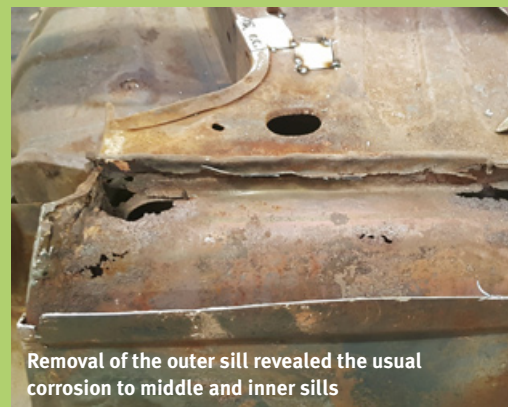
Removal of the outer sill revealed the usual corrosion to middle and inner sills

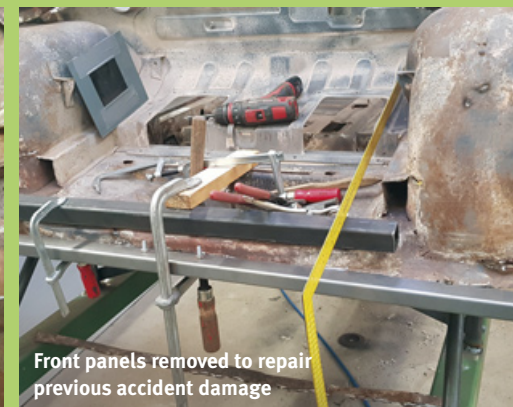
Since I have a metalworking workshop, cutting, bending and fabricating the initial repair panels wasn't a problem. Previous accident damage in the front

Front panels removed to repair previous accident damage

area was daunting at first, but I had the Stiletto at hand so was able to take the necessary measurements for the repair from that and make some templates.

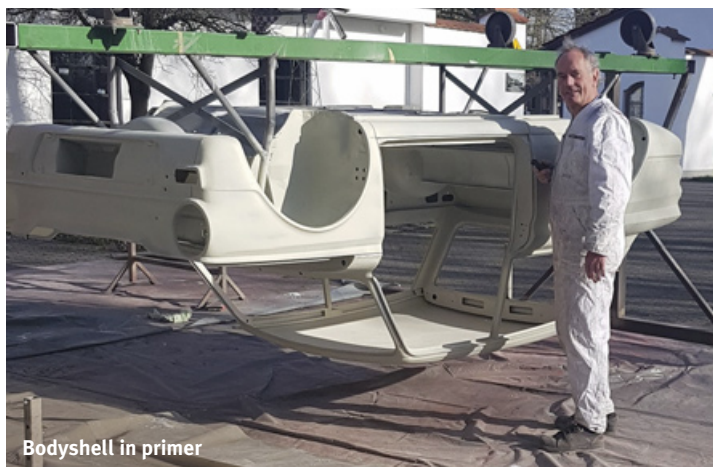
Bodyshell in primer

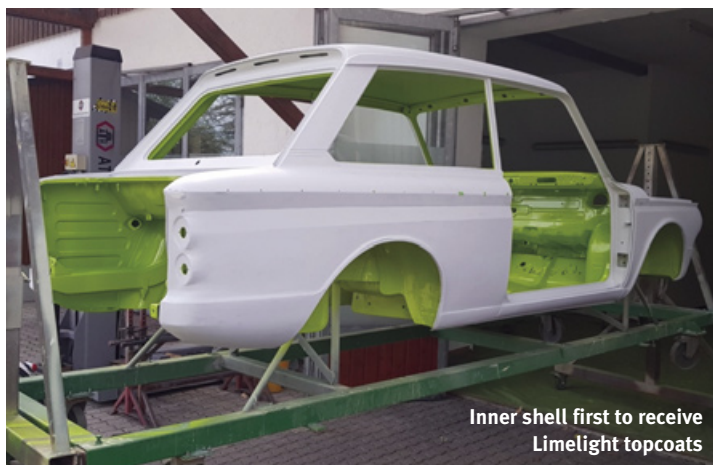
Inner shell first to receive  
Limelight topcoats

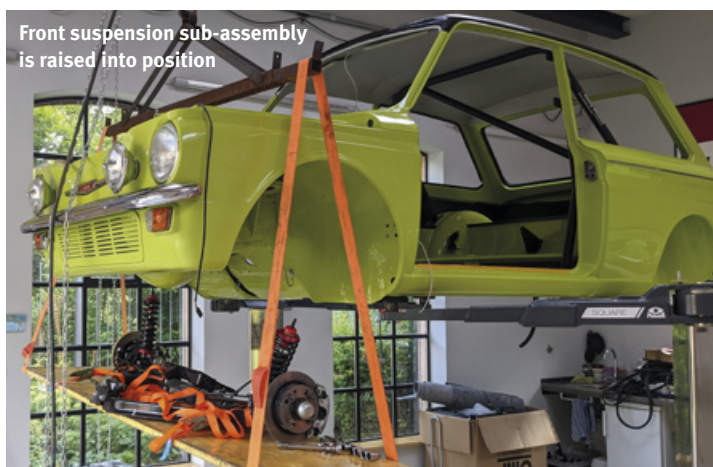
Front suspension sub-assembly  
is raised into position
